## **University of Warwick CP16 Access Junctions: Kirby Corner Road Access Junction**

### **Road Safety Audit Stage 1**

**TMS reference no: 13521**

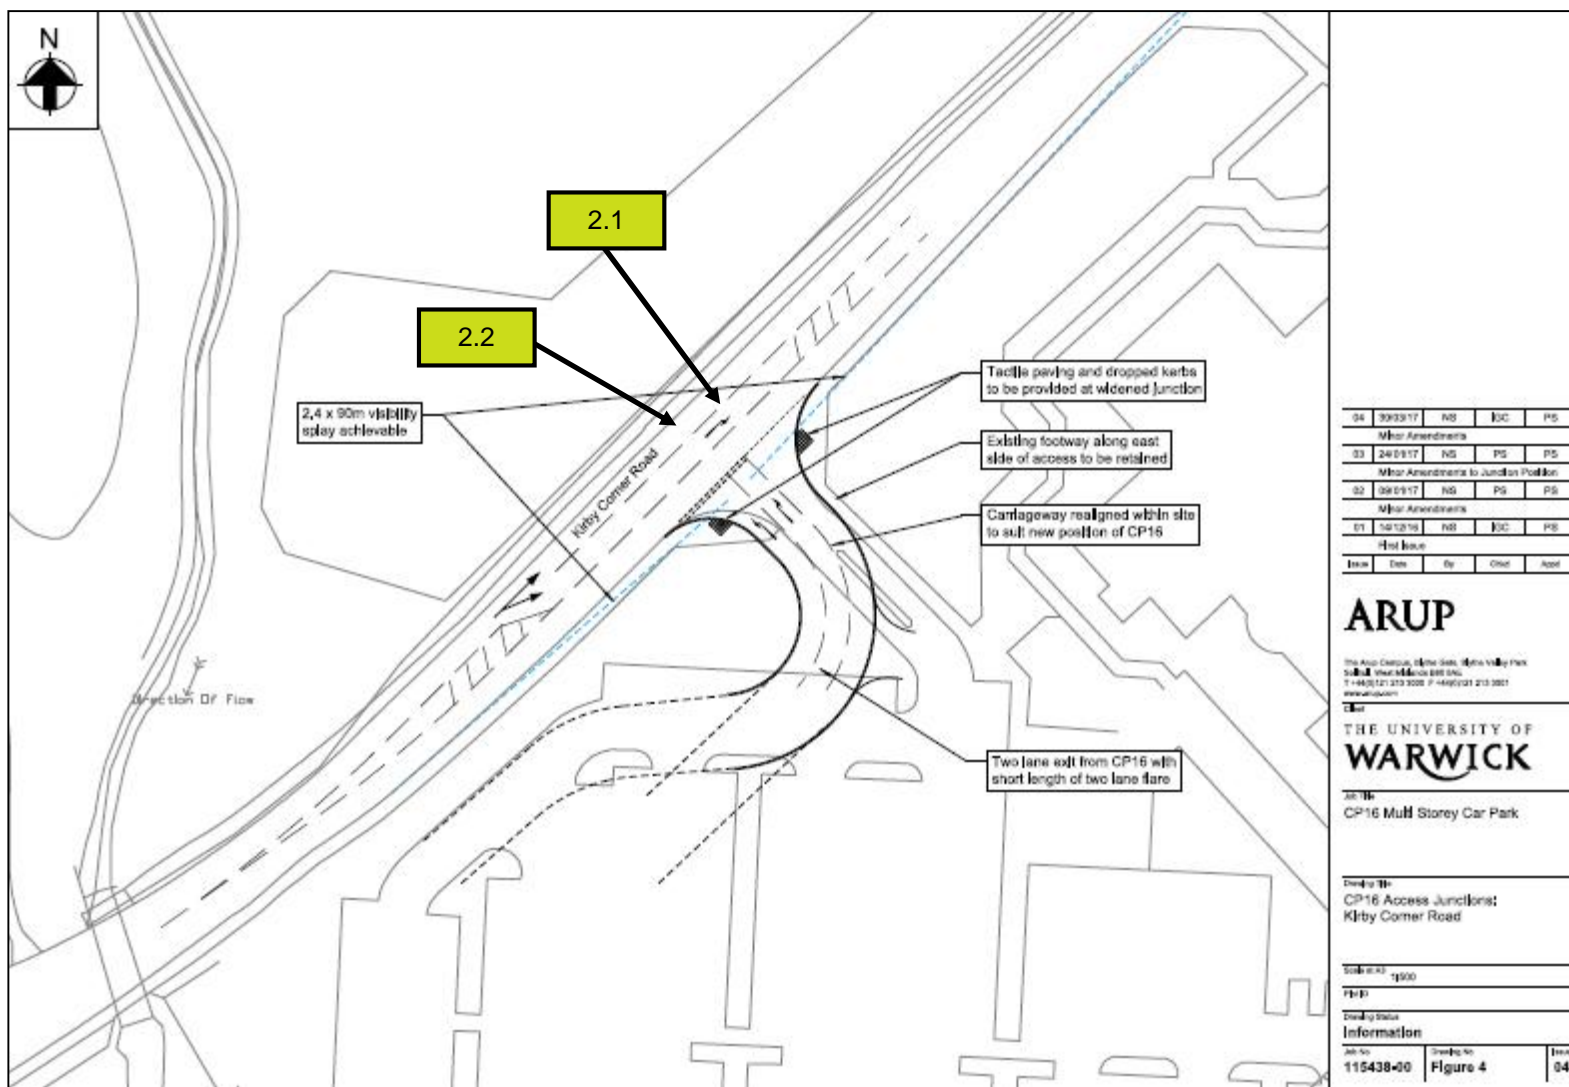
A sunken service chamber cover is located close to the access. There is a risk that motorcyclists leaving the access may lose control if they travel over this, particularly whilst turning.

The existing carriageway surface in the nearside lane was observed to be in a poor condition with longitudinal cracking. As this worsens it may present a loss of control hazard for turning or braking vehicles where braking capability may be reduced.

The cover should be reset so it is flush with the carriageway surface.

The carriageway surface should be repaired.
