Refurbishment Asbestos Survey

49 Corporation Street
Coventry
CV1 1GX

Abul Kashem and Mumin Ali

09 January 2019

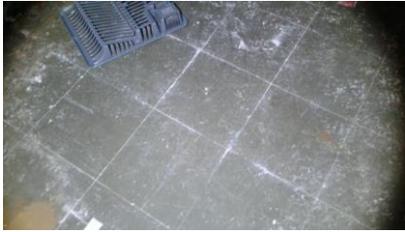
Location / Description	Photograph	Sample ref /Presumed	Licensed?	Quantity	Access.	Product	Condition	Surface	Asbestos Type	MRA Score	Comments / Recommendations
2nd Floor, 2nd Floor, 002 Floor Tile And Adhesive - Composite Green tiles below carpet. Also present in stairwell.

E-12134/VS0 01	N	90 m ²	Easy	1	0	0	Chrysotile to the tiles only 1	2 Very Low	If the material is to be disturbed during the refurbishment, removal is recommended. Manage
3rd Floor, 3rd Floor, 001 Floor Tile And Adhesive - Composite Green tiles. Also present in stairwell.

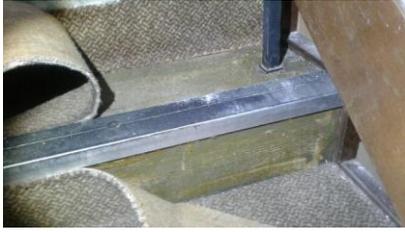
E-12134/S00 1	N	100 m ²	Easy	1	0	0	Chrysotile to the tiles only 1	2 Very Low	If the material is to be disturbed during the refurbishment, removal is recommended. Manage
Throughout, Stairwell, 005 Floor Tile And Adhesive - Composite Green tiles below carpet on concrete stairs and landing areas of stairwell. This material does not run from the first floor to the ground floor.

E-12134/VS0 01	N	40 m ²	Easy	1	0	0	Chrysotile to the tiles only 1	2 Very Low	If the material is to be disturbed during the refurbishment, removal is recommended. Manage

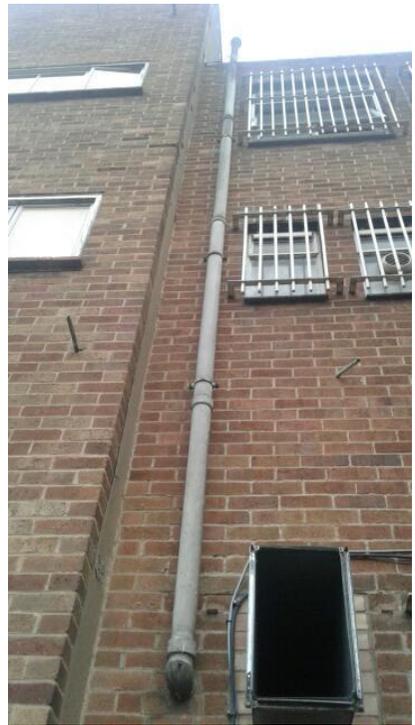
Location / Description	Photograph	Sample ref /Presumed	Licensed?	Quantity	Access.	Product	Condition	Surface	Asbestos Type	MRA Score	Comments / Recommendations
<p>External, 006 Vent Pipe - Cement Pipe enters the building on the 1st floor and is visual in the box work.</p>

<p>E-12134/S007</p>	<p>N</p>	<p>10 lin m</p>	<p>Easy</p>	<p>1</p>	<p>1</p>	<p>1</p>	<p>Amosite;C hrysotile 2</p>	<p>5 Low</p>	<p>If the material is to be disturbed during the refurbishment, removal is recommended. Manage</p>

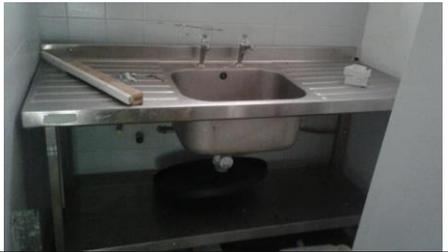
Location / Description	Photograph	Sample Ref	Asbestos Type	Comments
2nd Floor, Office A 002 Sink Pad - Bitumen

E-12134/S004	No Asbestos Detected in Sample	If the material is to be disturbed during the refurbishment, removal is recommended. To sink and draining board.
2nd Floor, Office B 002 Door Lining - Insulating Board

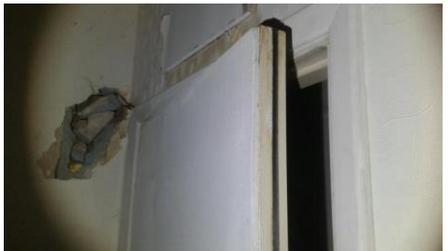
E-12134/S005	No Asbestos Detected in Sample	The work requires a licensed contractor and 14 day notification to the HSE. Superlux lining to door.
3rd Floor, Stairwell 005 Floor Tile And Adhesive - Composite

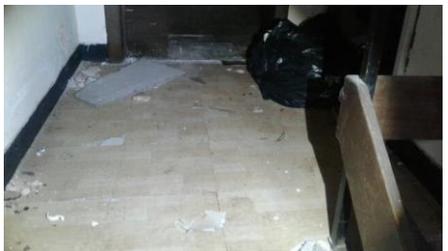
E-12134/S003	No Asbestos Detected in Sample	If the material is to be disturbed during the refurbishment, removal is recommended. Timber effect tiles top of stairwell.
Throughout, Stairwell 005 Stairs - Stair Nosing

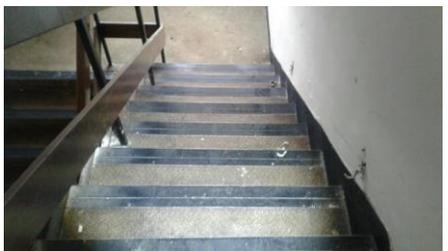
E-12134/S002	No Asbestos Detected in Sample	If the material is to be disturbed during the refurbishment, removal is recommended. Black nosings to concrete stairs.

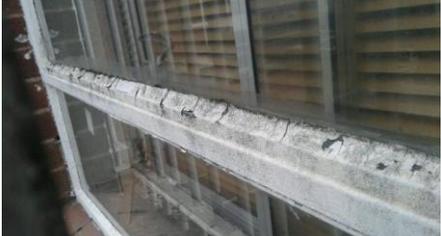
Location / Description	Photograph	Sample Ref	Asbestos Type	Comments
External 006 Window - Putty

A close-up photograph of a window frame showing a thick, greyish, textured substance (putty) applied to the metal frame. The putty appears to be made of glass and metal particles.	E-12134/S006	No Asbestos Detected in Sample	If the material is to be disturbed during the refurbishment, removal is recommended. Glass putty to metal windows.

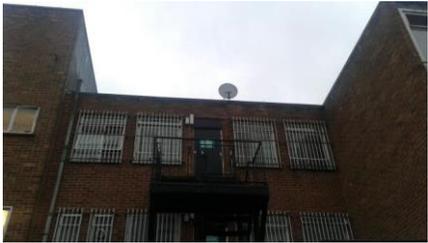
Location / Description	Photograph	Recommended Action
External 006 Roof - No Access Gained

Access was not possible due to height restrictions.
