Preliminary Ecological Appraisal

52 Woodshires Road, Coventry, CV6 6AA

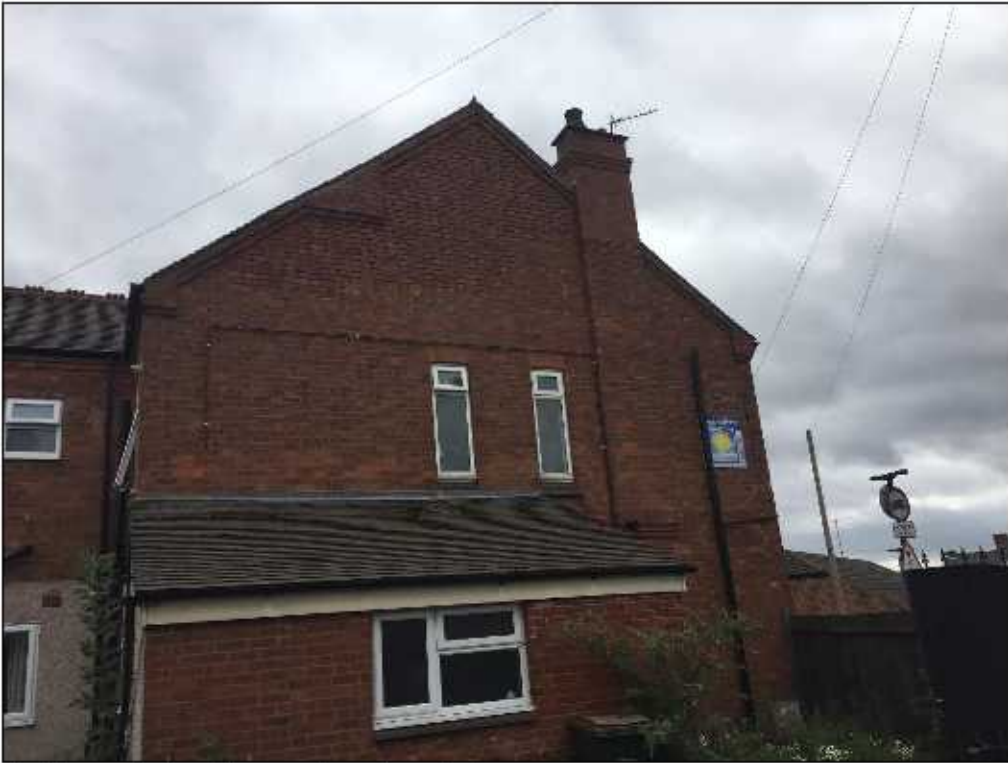
3.1.1 The building was situated within a suburban on the edge of a landscape dominated by arable habitats. The structure was constructed of brick pitched roof sections clad with clay plain tiles and clay ridges. The main roof and the roofs of the lean to single storey sections were well-sealed and no PRFs or bird-nesting features could be found. Some *Buddleia* had begun to grow at the north west elevation but was not significant enough to support any bird-nesting.

North west elevation roof well-sealed

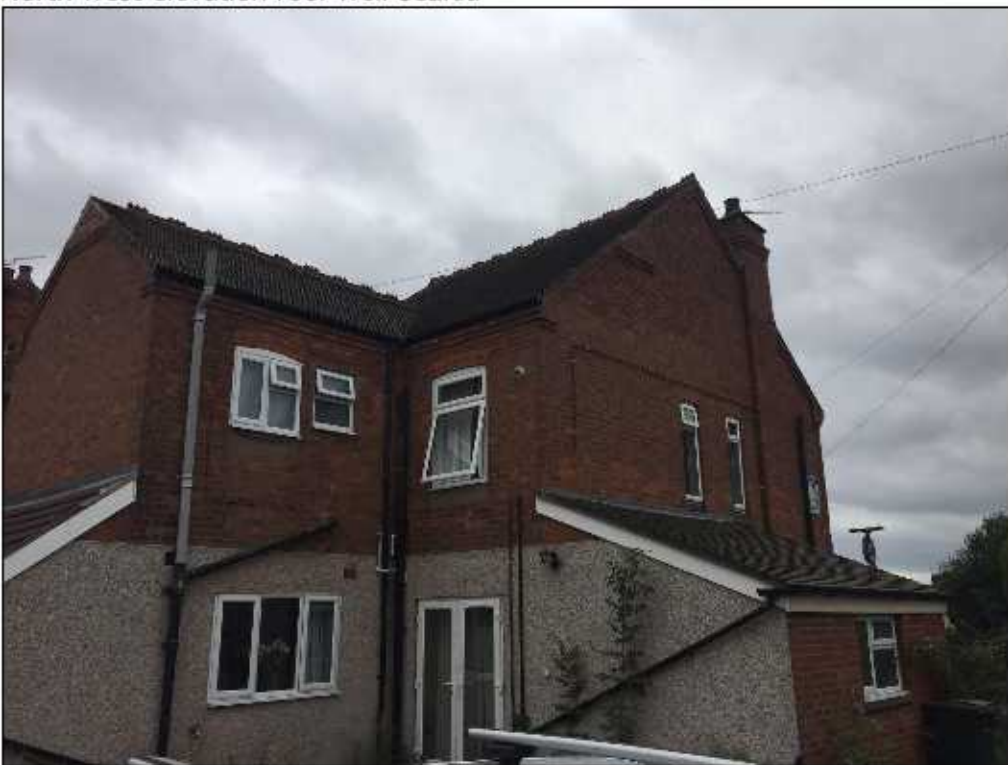
North elevation well-sealed roof

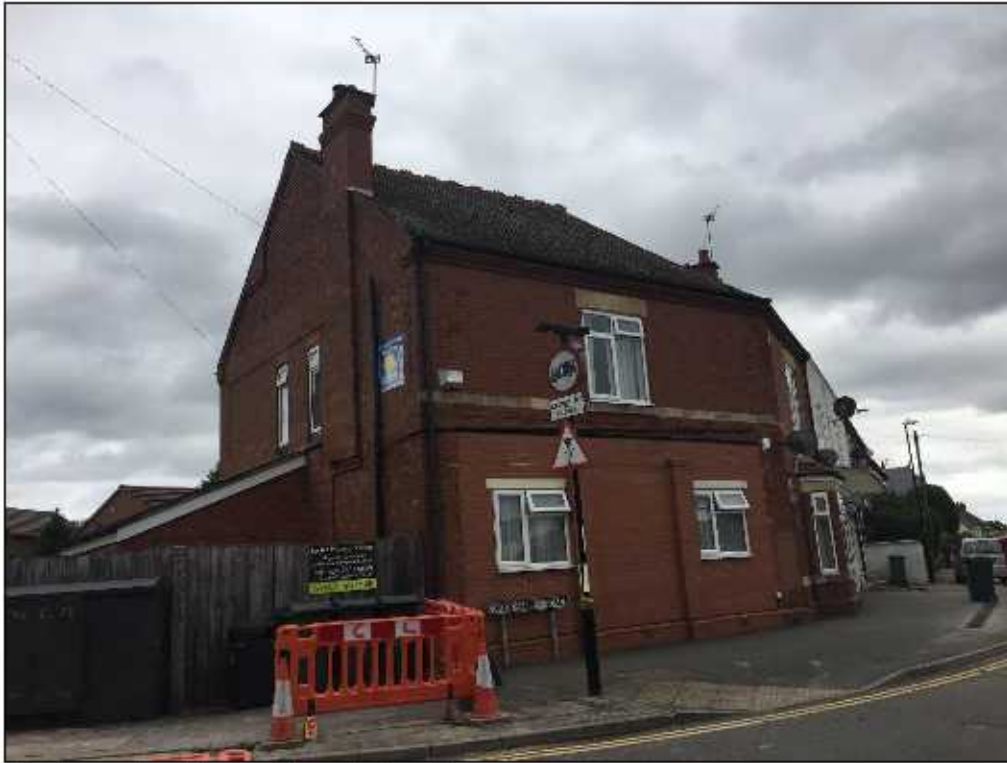
Western elevation well-sealed roof

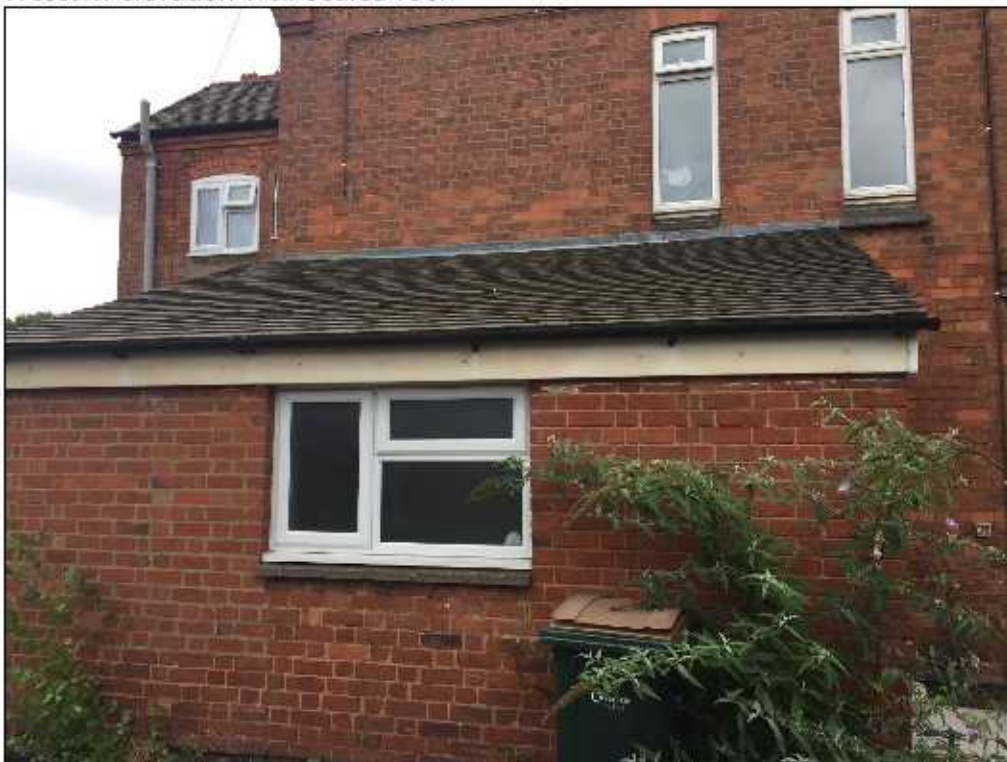
Lean to well-sealed

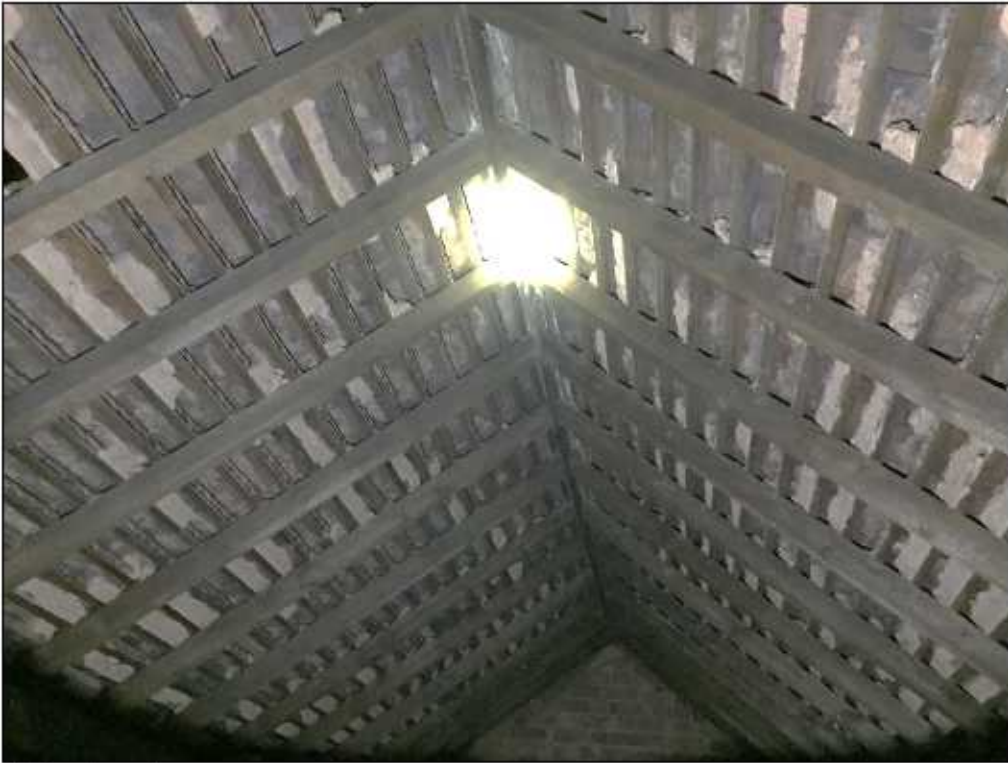
3.1.2 Inside the roof voids it could be seen that the roof was not lined and a fine covering of cobweb was present at the ridge indicating no bats had disturbed this area, and an layer of aged, undisturbed dust was present on all upper surfaces including the loft floor which was covered with insulation, although no evidence of bats or birds was present.

Unlined roof

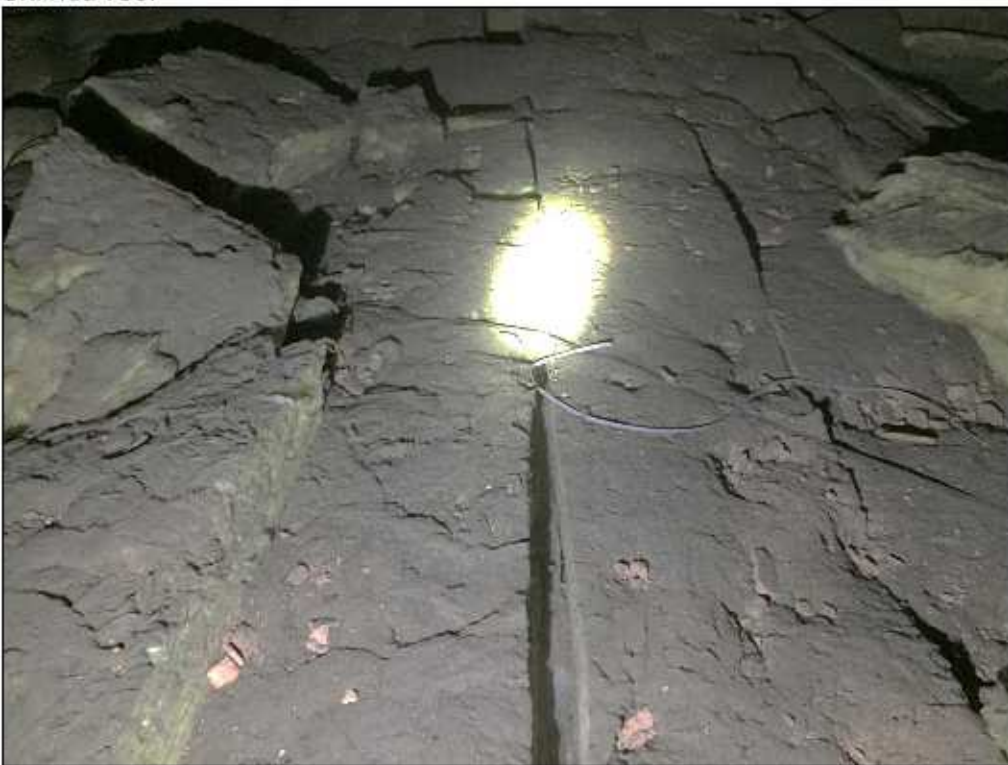
Significant dust at loft floor / no evidence of bats

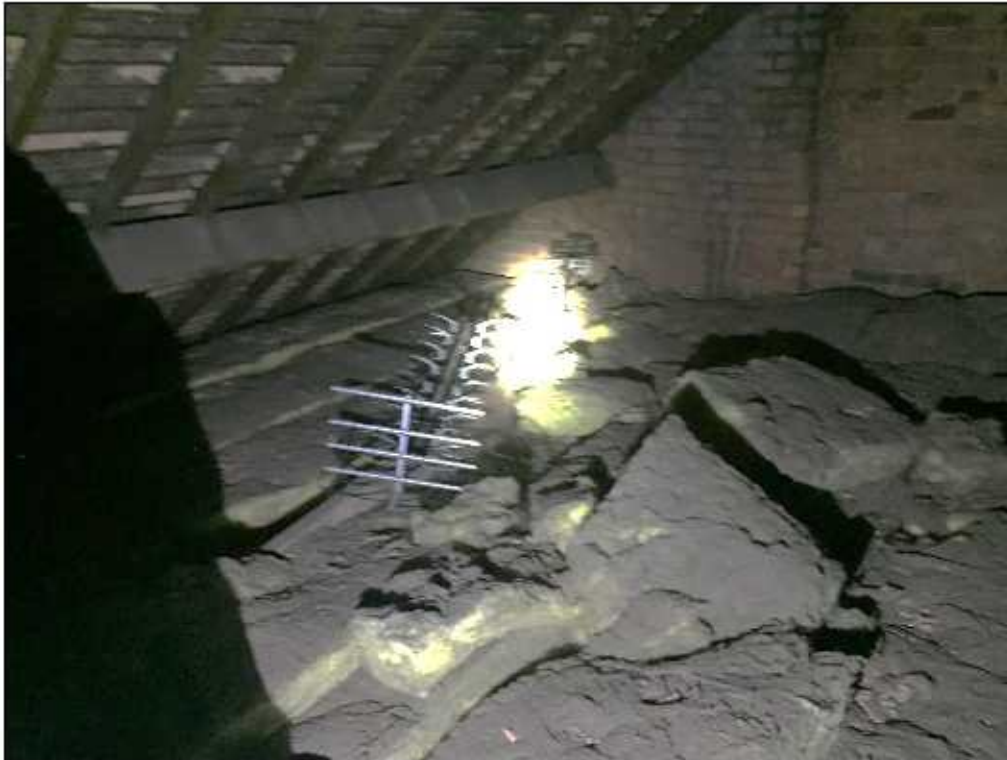
Significant dust at loft floor / no evidence of bats

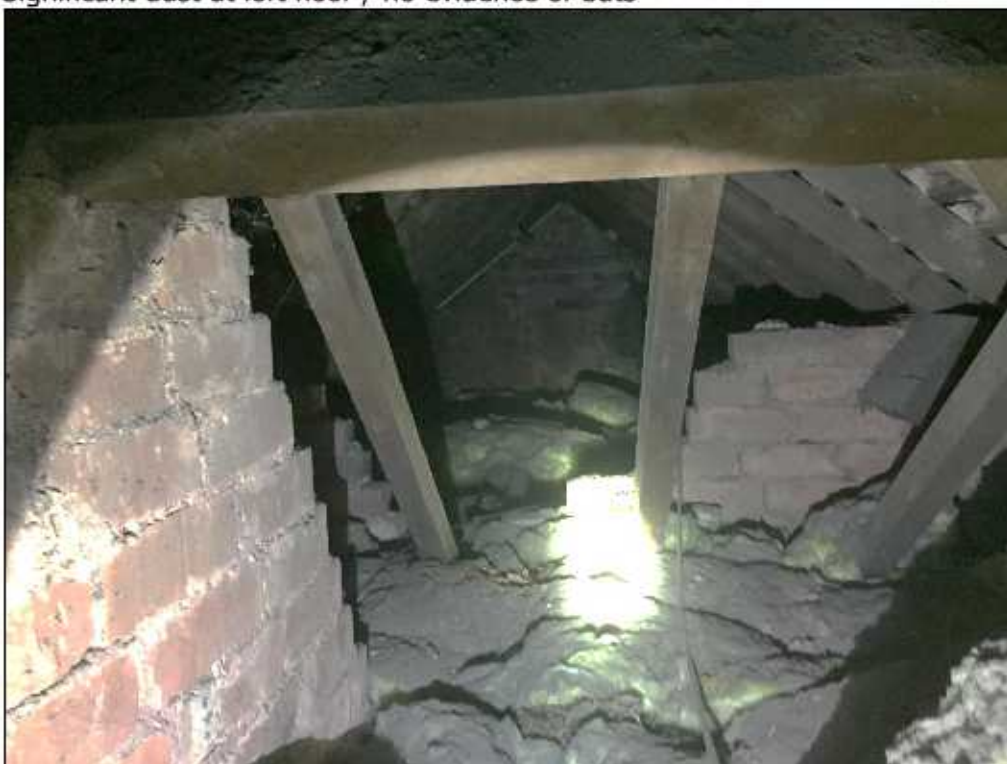
Significant dust at loft floor / no evidence of bats
