Preliminary Ecological Appraisal

Proposed Factory Extension, Meggit Site
Swallow Road off Holbrook Lane, Coventry

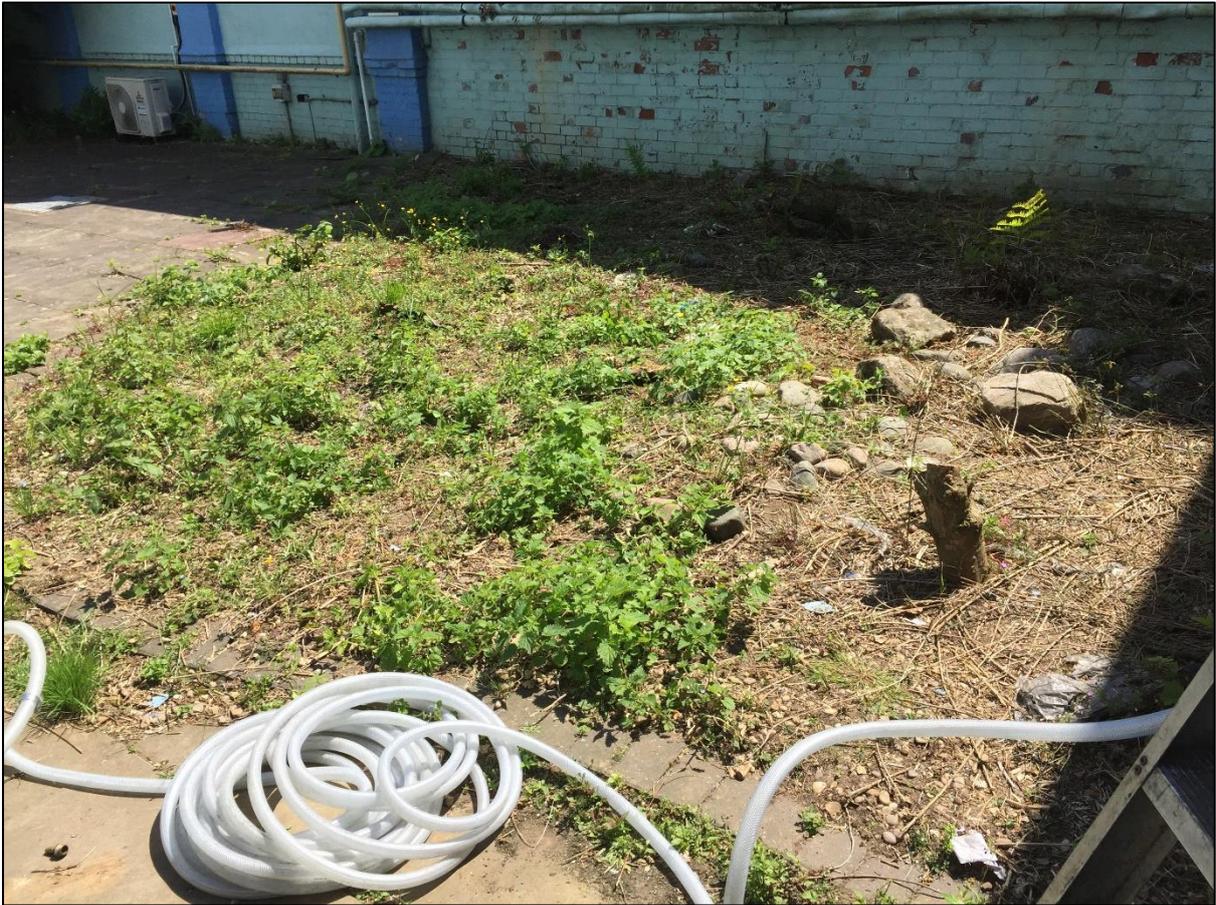
3.2.2 A small patch of vegetation was found at the interior courtyard, which supported mainly stinging nettle with creeping buttercup, with a few sparse grasses. The area had been cut back and offered nothing that would support any protected species.

Small vegetation patch within courtyard

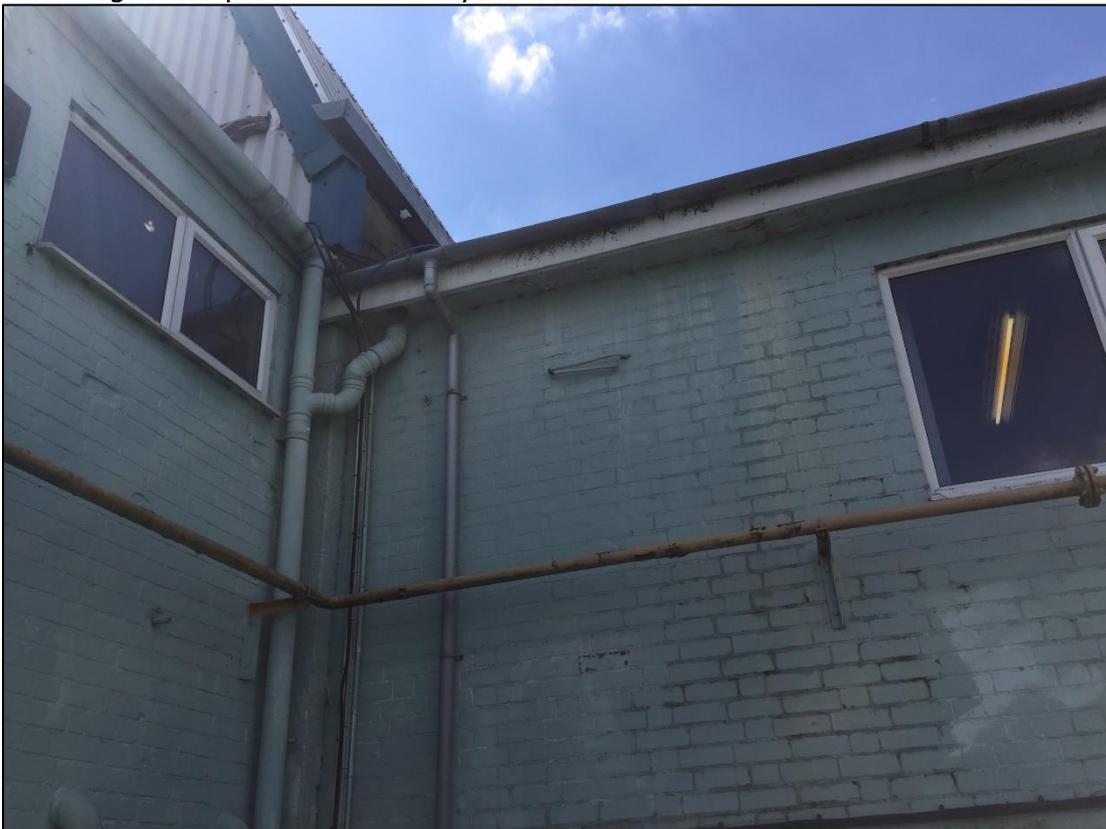
3.2.1 No evidence of bats or nesting birds was identified within the structures or at the exterior, although some opportunities for roosting bats and nesting birds were identified at the exterior of the buildings.

PRF / potential bird-nesting site at soffit

4.2 It is therefore considered that no further surveys will be required as the demolition is unlikely to impact bats.

4.3 Works to begin demolition should ideally start outside of the main bird-nesting season (March to August inclusive). If works to demolish cannot be timed to avoid this period, then it is recommended an Ecological Clerk of Works (ECoW) is appointed to oversee the demolition. If active bird nests are encountered at this time then the young will be left to naturally fledge prior to destruction of the nests site or sites.

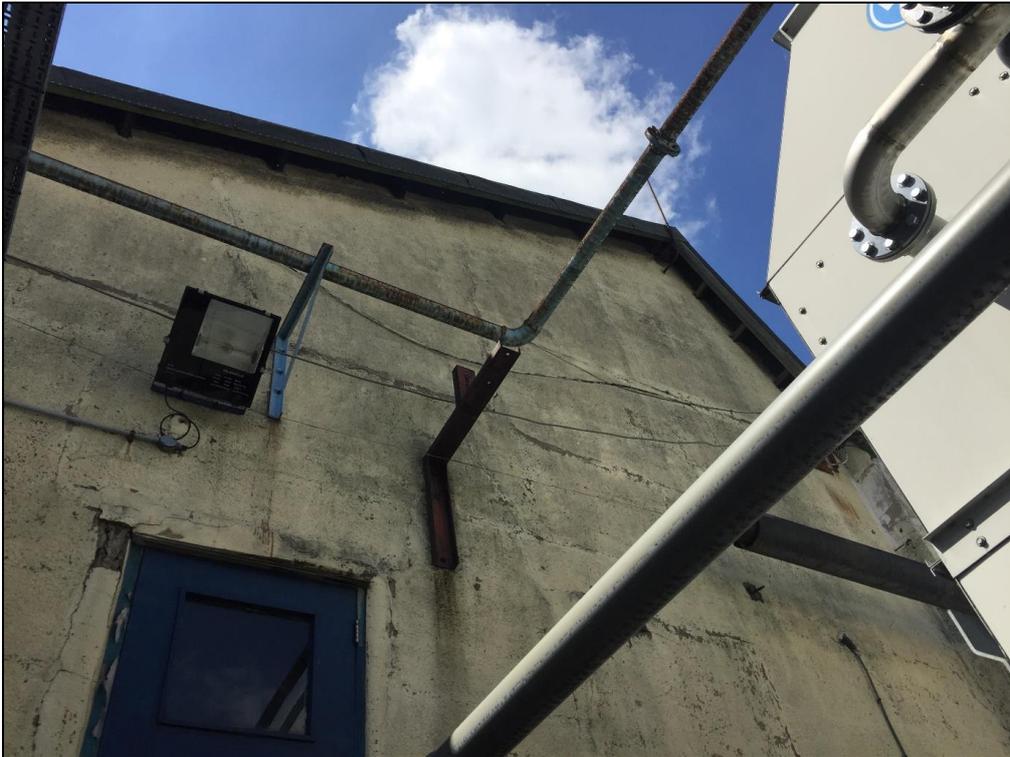
PRFs at east gable
