PRELIMINARY ECOLOGICAL APPRAISAL

52 WOODSHIRES ROAD, COVENTRY
CV6 6AA

Date: 27th July 2020
Client: Mr Luke Bird

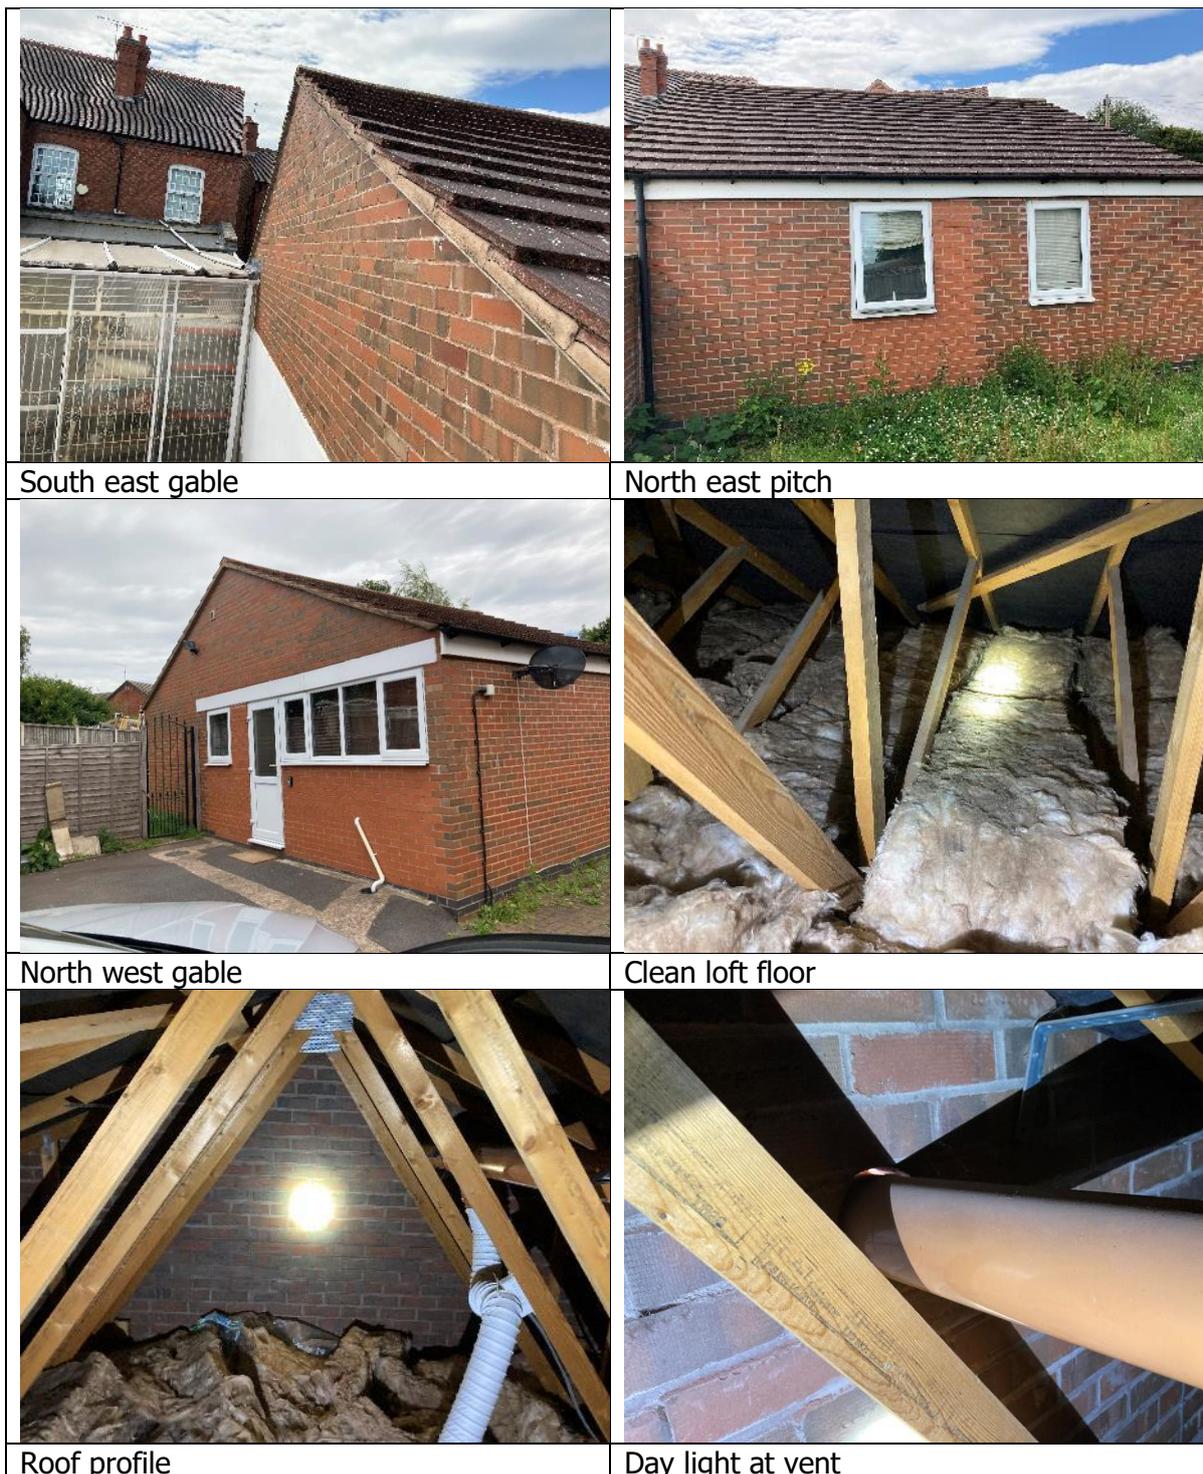
3.1.1 The building was situated within a suburban landscape on the edge of a Coventry with wider habitats dominated by arable agriculture. The structure was constructed of brick and had a pitched roof which was clad with concrete interlocking tiles. The fascia was UPVC and was tightly fitted to the masonry. The roof was well-sealed showing no PRFs or bird-nesting features.

3.1.2 Inside the roof voids it could be seen that the roof was lined with traditional bitumen felt and supported by light weight pre-constructed truss timbers. Day light entering the south west gable interior around an extractor vent, though this was sealed at the exterior with a grill. The loft floor was covered with insulation, and this was very clean with no evidence of bats or birds present.

4.1 No evidence of bats or birds could be found at the exterior or within the roof void. The site is located adjacent to moderate quality bat habitat where bats do occur in good numbers, but the structure is well-sealed and therefore does not show any suitable features that bats might use to roost, and as such is therefore currently considered to have negligible bat potential and so no further surveys will be required.
